## **PART II** **EXISTING CONDITION**

+ **EMS, Fire, Public Works**  
**Existing Facility Condition**  
**(aka “Town Garage”)**

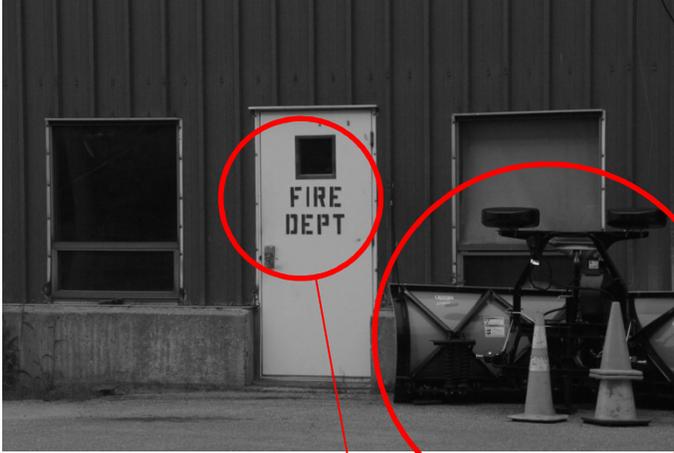
The stenciled lettering on the service-type door entryway is the only presentation to those entering the property of the presence of a fire department. The entry is often flanked by Public Works equipment, which can be an impediment in snowy conditions.

The placement of such equipment obviously diminishes the character of the entryway.

The lack of proper storage for Public Works equipment also exposes that equipment to harsher exterior conditions which, in turn, increases the need for maintenance, repairs and may shorten the equipment's working life. All this reduces the financial efficiency of the Public Works Department's operations.

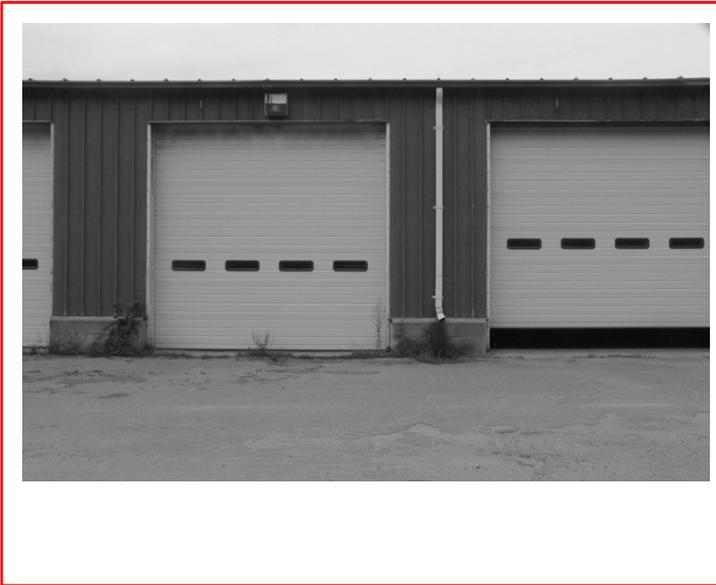
The Garage configuration now does not include any separating partitions between bays. This allows for rapid vacating of warm air in winter when any of the doors are opened, thus lowering the energy efficiency of the building dramatically. This also exposes those who may be working in the garage bays for extended periods to very cold temperatures in colder months.

This is an issue more for the Public Works Dept., where considerable work is done in fabricating road hardware and elements in winter, when their bay doors tend to be opened and closed frequently and so are much more vulnerable to loss of ambient heat in those bays.

Fire Dept. and EMS benefit from ease in vehicle access from their quarters when a call arrives. Those Departments thus enjoy a greater advantage in having open bays. These departments – unlike Public Works - tend, however, to benefit from their bay doors remaining closed on off times, so in a new structure may retain heat to a higher degree of efficiency. This will be a notable design issue to address for the Design team.

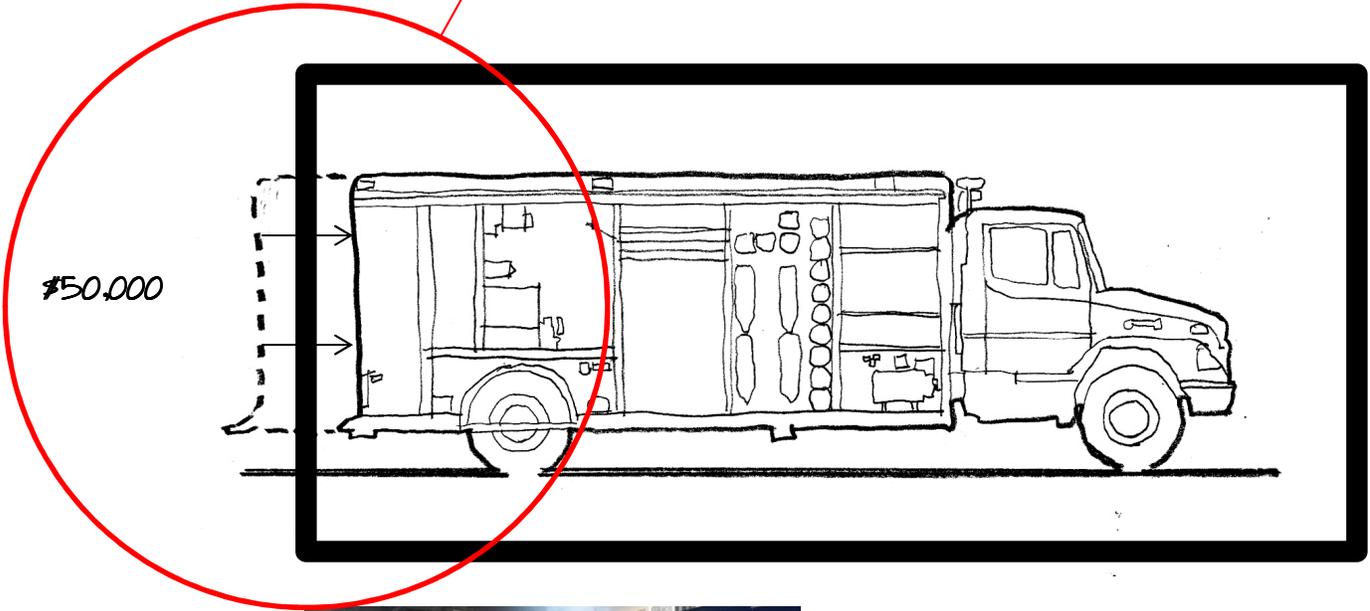
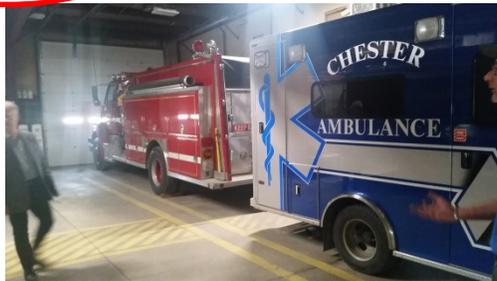
← EXISTING, ALLOTTED PARKING BAY LENGTH →

The length of Fire Department parking bays is now not sufficient to accommodate stock emergency vehicles, requiring an added Town expense at the time of **each** filed vehicle order of approximately \$50,000 simply for altering the truck length prior to delivery to the Fire Department.

Vehicle length must be adjusted to fit exg. Bays.

Over just a decade or two (*depending on configuration; design*) the savings in avoiding this additional effort may well pay for the additional cost of longer department parking bays.

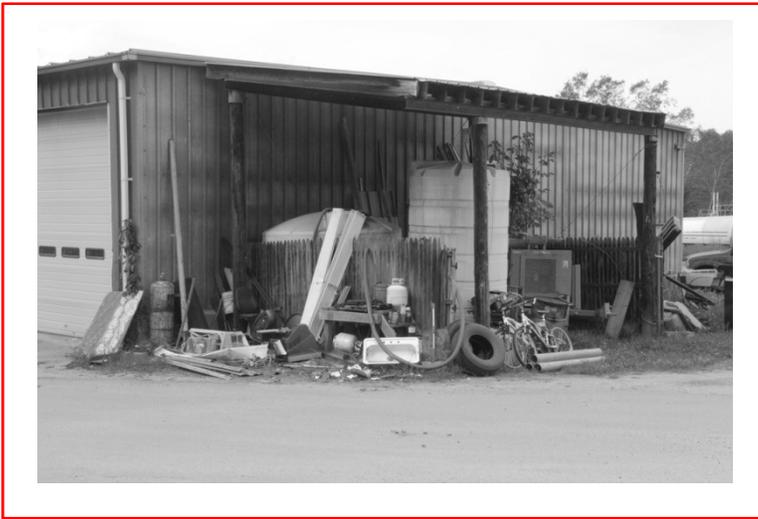
The south face of the current Town garage structure has scabbed to its side an ad hoc storage overhang for miscellaneous equipment, supplies, etc. Despite the overhang, the items in question remain clearly exposed to the elements, likely hastening their deterioration.

This also contributes to the extreme unsightliness of the property. To many this may not be an issue if their sole priority is “function”; however, there are those in all Departments who have – in confidence - expressed at least a degree of frustration at the site’s appearance and thus it’s projection of the various Departments’ apparent efficiency.

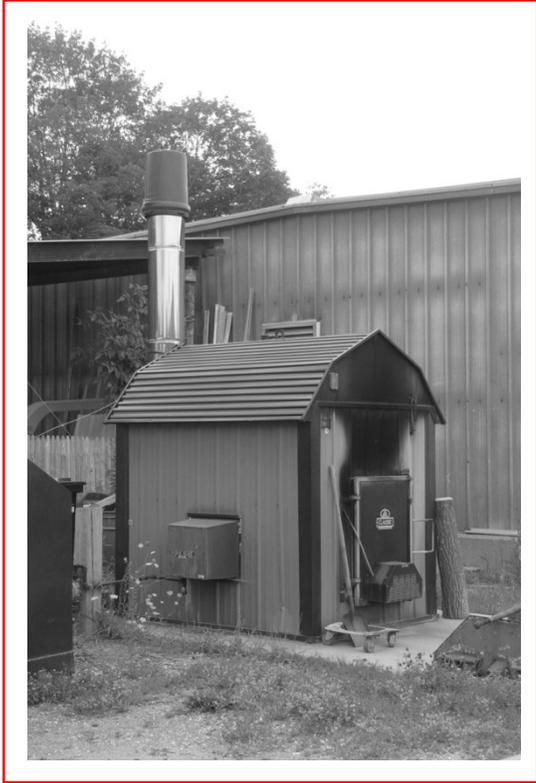
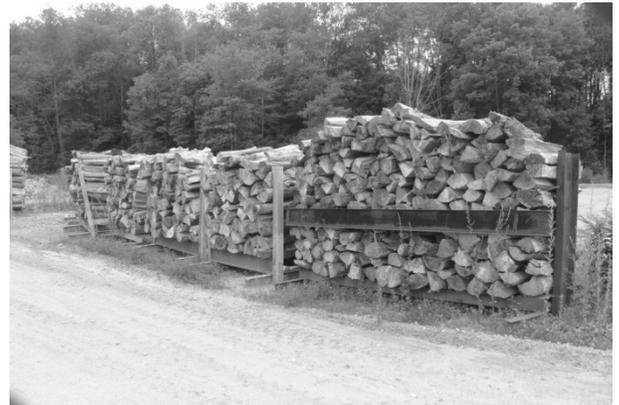
Imbedded in the stored items at the south façade is the primary heat source for colder months, a wood burning furnace which requires manual attention at all times it is in use.

On-site wood storage, south of Town garage.

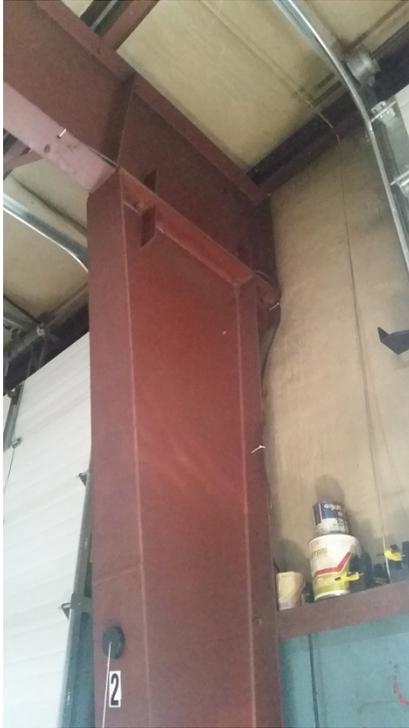
Moving to the interior of the structure, it's observed that the primary structural elements appear to be in sound condition and thus we would recommend the design team consider their re-use for the "Pole barn" storage facility under request by Public Works. This will allow for a considerable savings of cost in construction, requiring only certification by a licensed structural engineer prior to re-installation.

2017 image of actual column-beam intersection in existing "Town Garage" structure. (CV A)

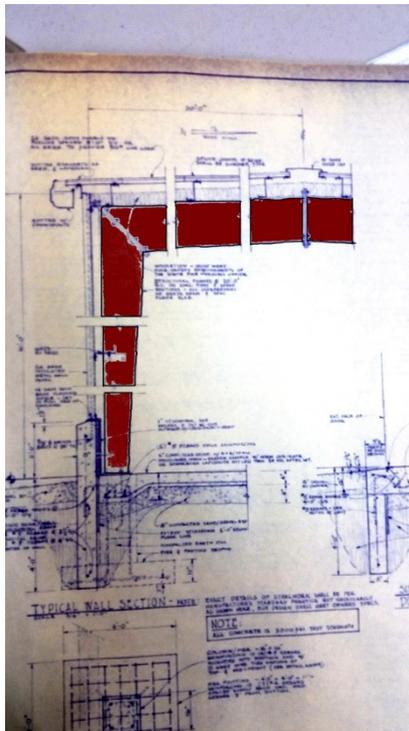
Segmented elevation view of the existing, prefabricated support column/beams.

These appear to be in good condition and may be considered for re-use in supporting "Pole Barn" storage structure. (CV A image of original WD print – shaded areas added for emphasis)

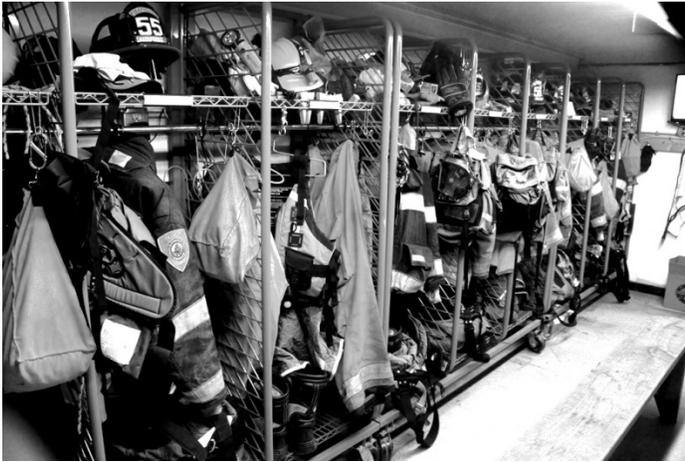
Current Fire Department Lockers

Fire Department locker storage is insufficient. Over the past couple decades equipment has increased in bulk and while the current lockers, recently installed, are able to hold the firefighter's equipment, there is insufficient space to don the clothing and equipment required to respond to a call, especially with more than a couple of firefighters so engaged in the same space and time. ***This condition may be negatively impacting; increasing call response time.***

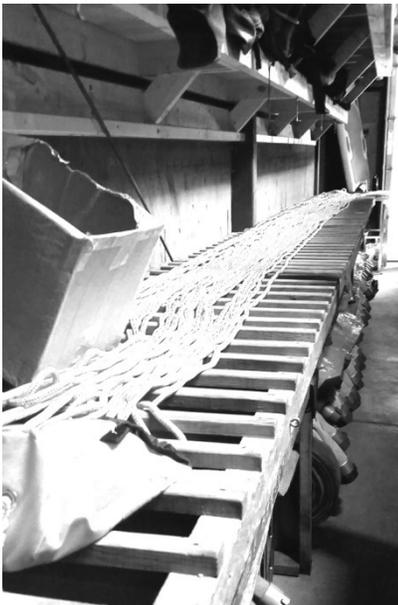
Hose drying rack

Currently, the hoses are dried on a horizontal rack. This enjoys the advantage of allowing moisture to evaporate evenly along the length of the hose and, based on the interviews with the current users, is preferred over a tower drying system. This also makes inspection and any repair a much easier task. The floor area consumed by the long racks is only marginally greater than the square footage needed for a tower footprint, but certainly less expensive to construct.

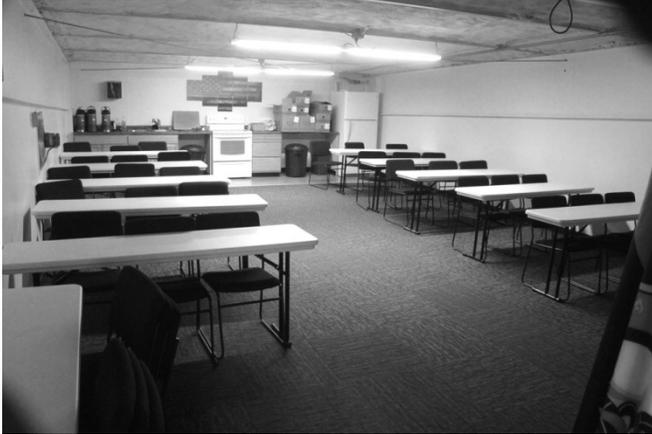
Current Training Room at head of stairs, below. Inadequate lighting, No second means of egress; no exterior light or view.

One of the more concerning current conditions and which secured the attention of building inspectors is the prior conversion of what was designated as an attic storage space into a training room and kitchen area.

The concern is that the entryway is at the head of a stairway and the only entry into the space. The EMS storage and office areas are also at the top of the single stairway approach. This is clearly a serious fire hazard, ironically in a fire department building, that represents a key example of the ad hoc approach that has been taken in the past to accommodate expansion of Town service's needs.

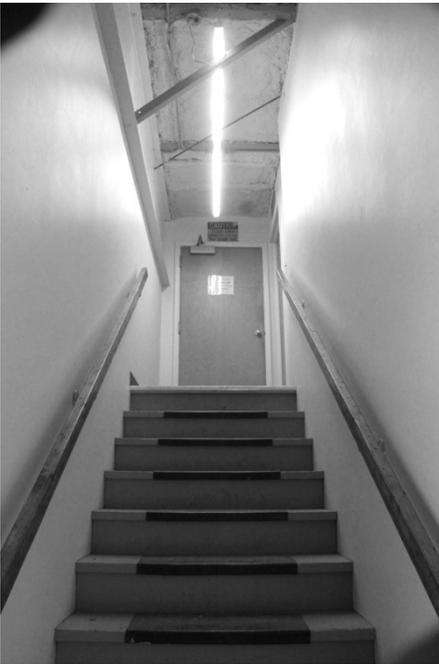
Single means of egress from Training Room and EMS offices/storage area to the right at head of stairs.

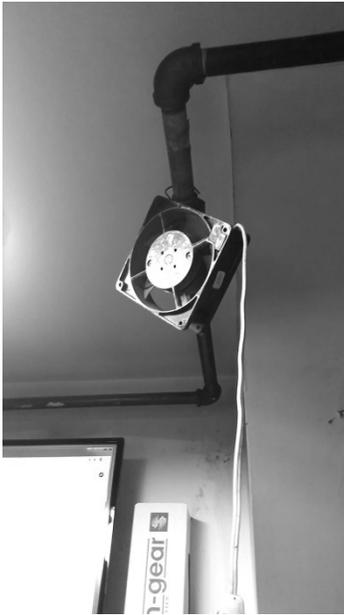
As the illustration makes clear at left, HVAC is effectively absent from the current building. There is an efficient heating system in the form of the wood burning furnace, described above, which heats the entire structure in colder months. However, according to the current users, summer heat can be difficult with the lack of air circulation, as is now the case.

Ad hoc “ventilation system”

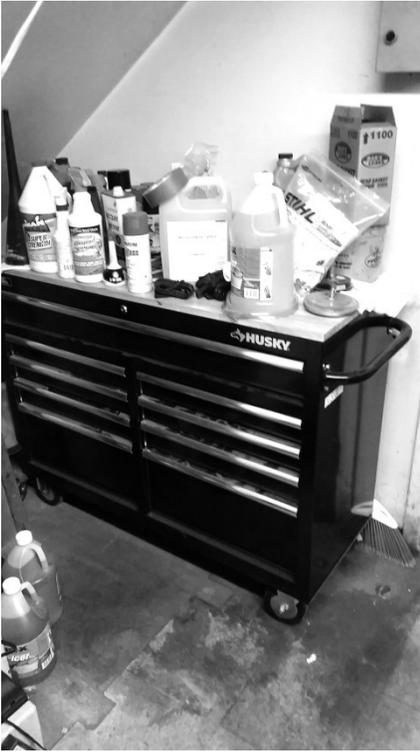
“Storage arrangement” – a common configuration throughout Town garage, due primarily to no significant accommodation in original “design”.

One of the clear issues a Design team will need to consider in the Program will be specific storage needs throughout all departments. The original structure was designed in a largely arbitrary manner and seems not to have taken account, in any serious manner, the future likely storage requirements for all departments. As we describe elsewhere in this document, this also applies to the Police Department needs in Town Hall. In all these cases it is more the need for an improved design configuration than an actual lack of space that is the core issue to be addressed in all departments. The staff has improvised, created their own storage arrangements or taken a “just put things over there, for now...” – approach. The improvement in efficiency, morale and appearance would all be marked with just straightforward design approaches based on what the users have described.

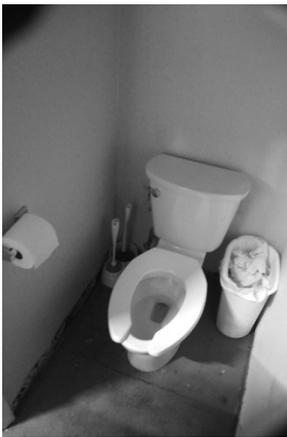
Existing FD washroom, which is accessible to the public.

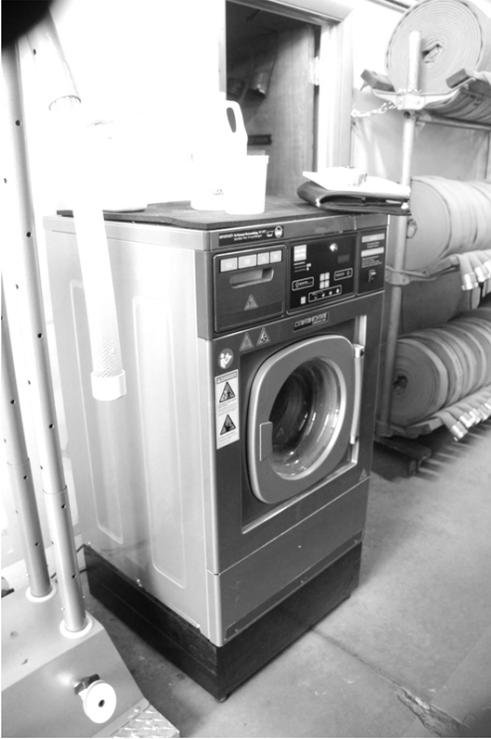
FD Laundry and hose storage  
located along vehicle parking bay  
wall

Fire Department storage of equipment is largely placed along the perimeter walls of the current vehicle parking bays. This makes for direct access and workability with respect to supplying emergency vehicles. A key point called for by the current users was to prefer a “closed” back wall for the vehicles; equipment; that backing into the bays was not considered an issue and would allow for a great deal more storage wall space.

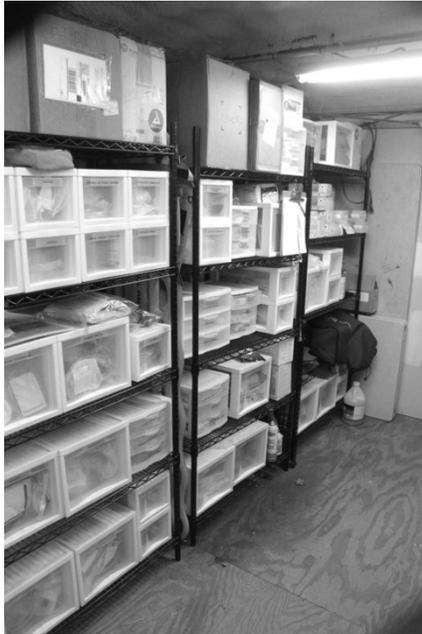
EMS medical supply storage.

By necessity, EMS medical supply storage currently displays a relatively high degree of efficiency, but the upstairs installation appears to include inadequate; uneven lighting.

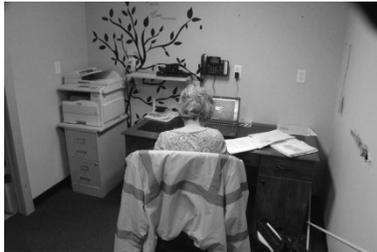
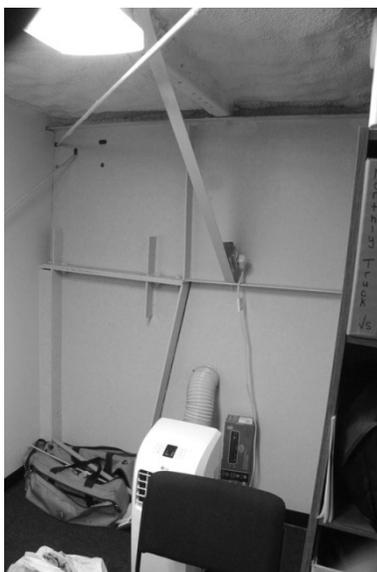
Current EMS staff office.

Perhaps the most inadequate space in the EMS department at this time is the staff office. It was created by simply building wallboard walls and a door in an upstairs corner of the storage area. There is no natural lighting, and the fluorescent fixture used causes foreshadow on the staff members work area. In short, this makes for a wholly inadequate work space.

In the new facility we'd strongly recommend application of even basic ASID/ADA work area standards, none of which are in place in the current workspace.

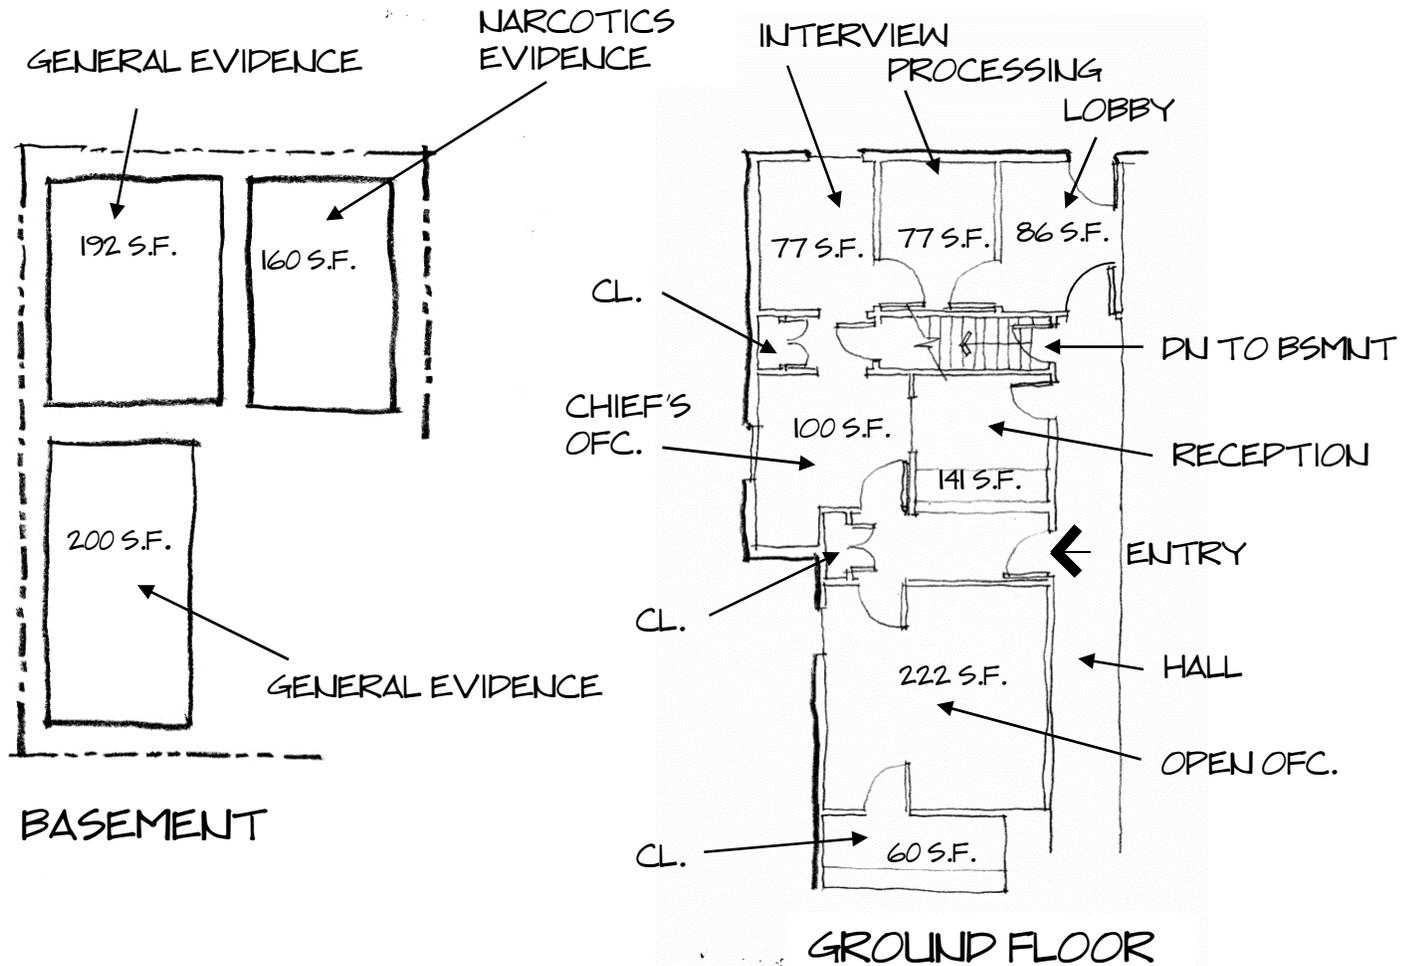
Existing (schematic) Basement + Ground Floor - Floor Plan indicating areas. See also Appendix large scale 3D perspective of existing and potential expansion areas. (Robert Buchan/CV A)

NO ACCESS TO OTHER SPACES IN DEPT EXCEPT BY EXITING TO PUBLIC HALLWAY AND RETURNING.

The existing Reception area is awkwardly configured such that the Receptionist must exit to the public hallway and then back into the Department to interact with the rest of Staff.

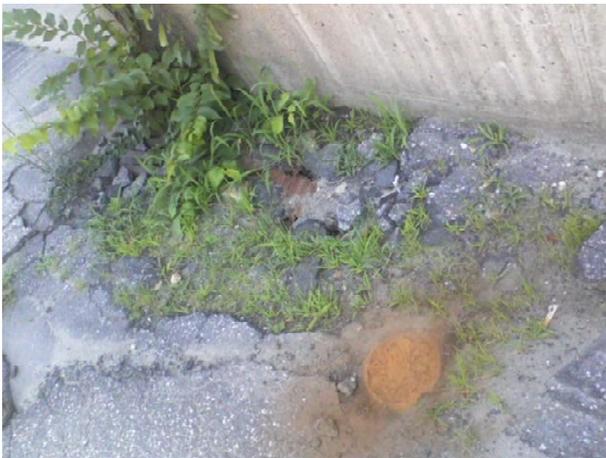
3. A damaged exterior catch-basin grate was noted adjacent the entrance to the office bay. It

Existing catch-basin cover and water stop valve cover.

is not known where this discharges.

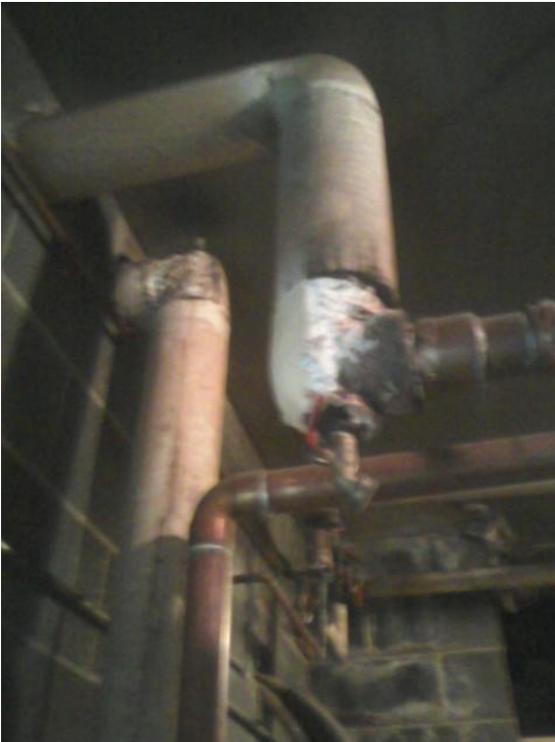
4. Within the building, fragments of asbestos remaining from a previous remediation project and flooring mastic that may contain asbestos were observed.

Existing asbestos remaining in boiler room.

- A. Investigations of potential hazards that would affect the cost of a future Project.
- B. Prices to remediate identified hazards that might be best addressed immediately.
