## **PART II** **EXISTING CONDITION**

+ **EMS, Fire, Public Works**  
**Existing Facility Condition**  
**(aka “Town Garage”)**

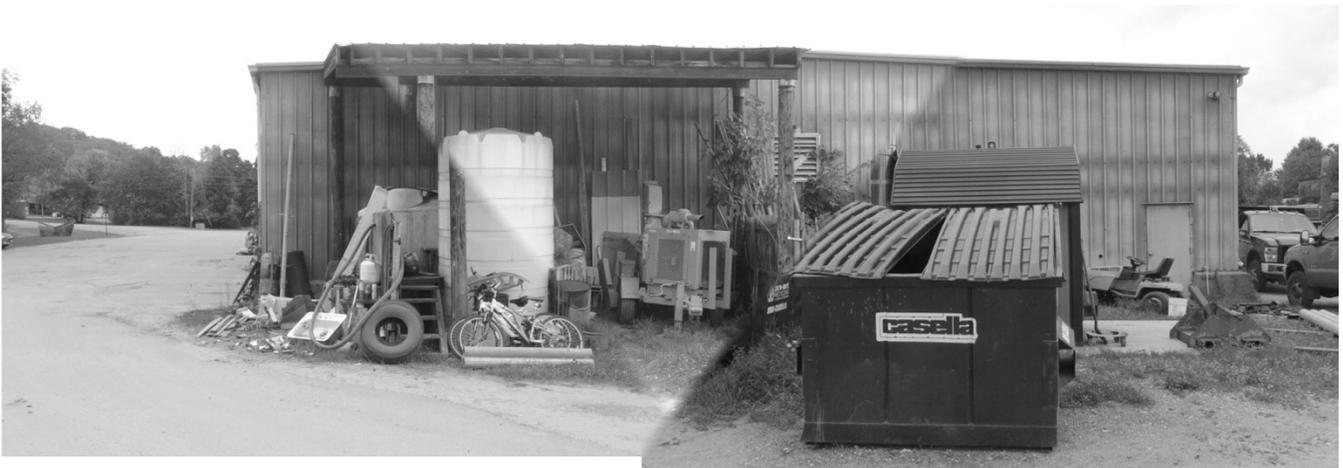
The existing “Town Garage” site is a product of numerous years of casual; “making do”, ad hoc construction and improvisational common sense accommodation of equipment storage, casual parking, exposed facilities and scab construction, some of which has been identified by State Fire & Safety as in violation of code. Two inspections – one in **July, 2016** and a second in **March, 2017** - revealed numerous State Code violations. The Town soon after was

informed that noticeable progress needed to be observed to avoid State intervention and further imposed requirements to address the inadequate accommodations for three of the four Town Services: EMS, Fire and Public Works. These are the three departments currently housed in what has come to be known, generally and locally, as the “Town Garage”

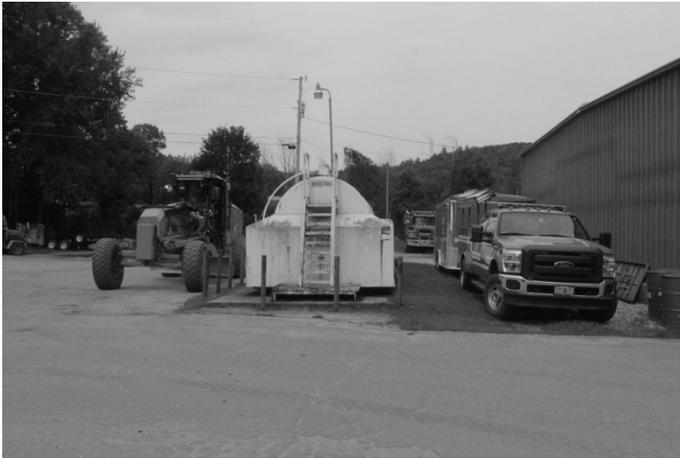
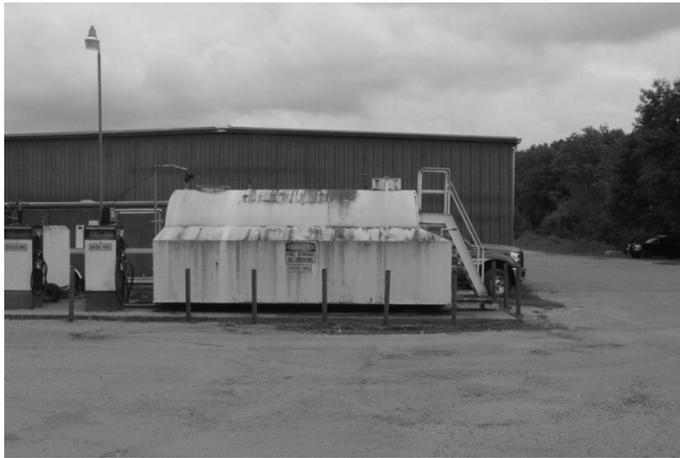
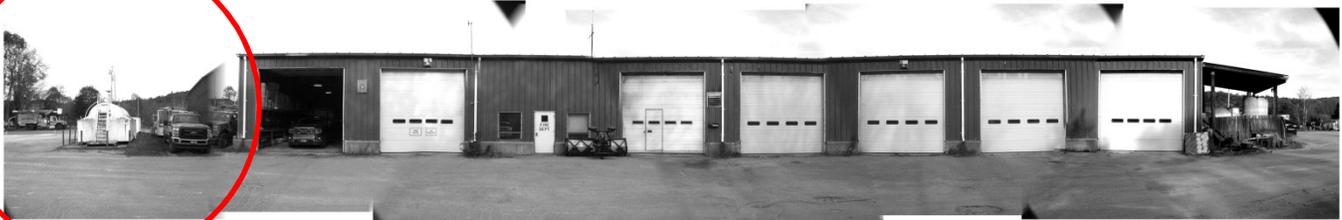
Greeting those who enter the current grounds is a Town vehicle fuel tank on a concrete slab, engaged in a concrete collar.

The stenciled lettering on the service-type door entryway is the only presentation to those entering the property of the presence of a fire department. The entry is often flanked by Public Works equipment, which can be an impediment in snowy conditions.

The placement of such equipment obviously diminishes the character of the entryway.

The lack of proper storage for Public Works equipment also exposes that equipment to harsher exterior conditions which, in turn, increases the need for maintenance, repairs and may shorten the equipment's working life. All this reduces the financial efficiency of the Public Works Department's operations.

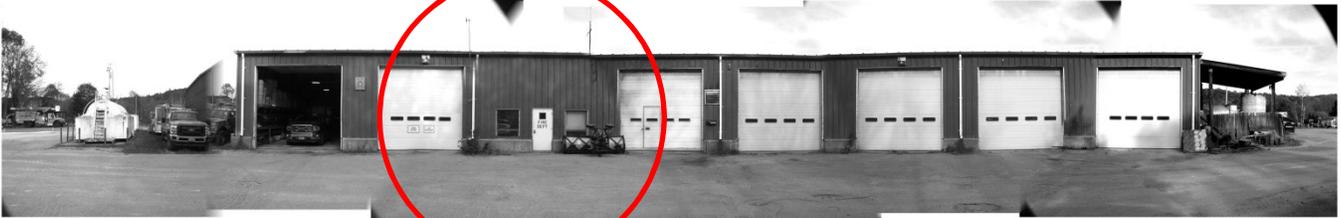
The Garage configuration now does not include any separating partitions between bays. This allows for rapid vacating of warm air in winter when any of the doors are opened, thus lowering the energy efficiency of the building dramatically. This also exposes those who may be working in the garage bays for extended periods to very cold temperatures in colder months.

This is an issue more for the Public Works Dept., where considerable work is done in fabricating road hardware and elements in winter, when their bay doors tend to be opened and closed frequently and so are much more vulnerable to loss of ambient heat in those bays.

Fire Dept. and EMS benefit from ease in vehicle access from their quarters when a call arrives. Those Departments thus enjoy a greater advantage in having open bays. These departments – unlike Public Works - tend, however, to benefit from their bay doors remaining closed on off times, so in a new structure may retain heat to a higher degree of efficiency. This will be a notable design issue to address for the Design team.

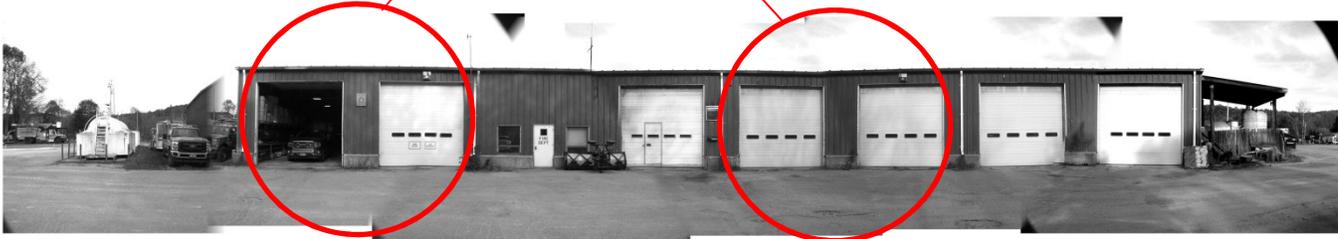
← EXISTING, ALLOTTED PARKING BAY LENGTH →

The length of Fire Department parking bays is now not sufficient to accommodate stock emergency vehicles, requiring an added Town expense at the time of **each** filed vehicle order of approximately \$50,000 simply for altering the truck length prior to delivery to the Fire Department.

Vehicle length must be adjusted to fit exg. Bays.

Over just a decade or two (*depending on configuration; design*) the savings in avoiding this additional effort may well pay for the additional cost of longer department parking bays.

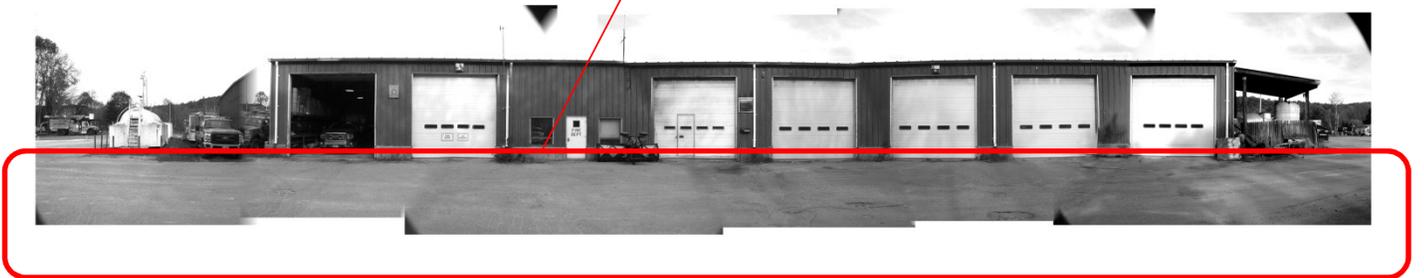
A major concern expressed by Fire Dept. staff is the perpetual frustration of dust accumulation on vehicles and equipment. This appears to be due to traffic flow outside the garage bays and the frequent opening of the garage bay doors.

The current condition of the traveled driveways allows for dust to be lifted and to travel throughout the site. The unpaved drive is also situated to the west and north, thus being vulnerable to prevailing winds conveying the dust into and around the current garage.

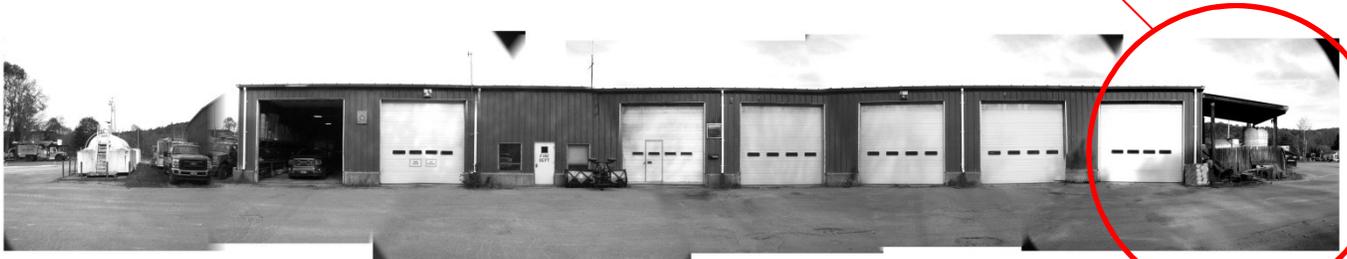
The south face of the current Town garage structure has scabbed to its side an ad hoc storage overhang for miscellaneous equipment, supplies, etc. Despite the overhang, the items in question remain clearly exposed to the elements, likely hastening their deterioration.

This also contributes to the extreme unsightliness of the property. To many this may not be an issue if their sole priority is “function”; however, there are those in all Departments who have – in confidence - expressed at least a degree of frustration at the site’s appearance and thus it’s projection of the various Departments’ apparent efficiency.

Imbedded in the stored items at the south façade is the primary heat source for colder months, a wood burning furnace which requires manual attention at all times it is in use.

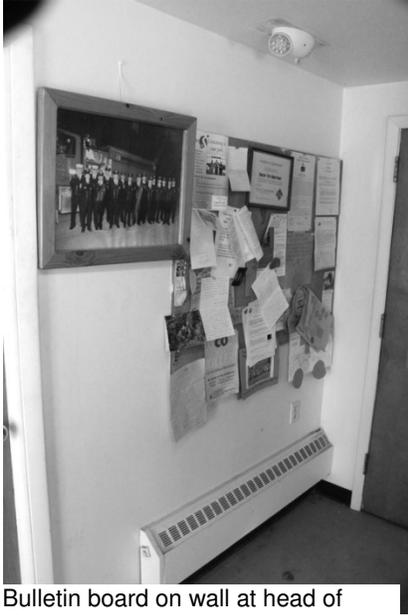
Bulletin board on wall at head of single-egress stair.

The call for a venue to display the history, character and current activities of each of the departments we recommend as being of high priority. Institutions enjoy a level of self-identity no less than individuals do. Properly displaying historical images and artifacts can have a profound impact on staff morale and inform the visiting public as to the significance of the department's relationship to the community.

In light of these points, we strongly recommend the project Design Team considers the inclusion of such venues in each department as the users may describe.

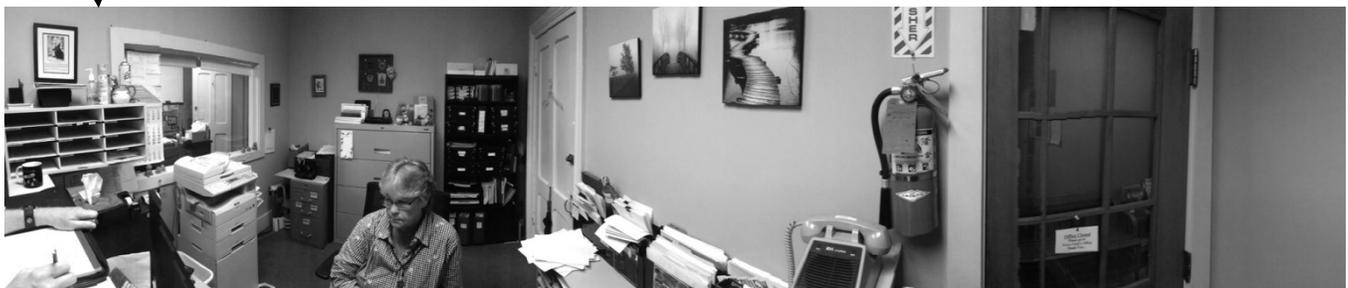
NORTH ENTRY OFF CENTRAL HALLWAY IN TOWN HALL

SECOND ENTRY, ALSO OFF CENTRAL HALLWAY: ONLY EXIT FROM RECEPTION/ADMINISTRATION

This poses grave potential security and safety concerns in the event of incidents with difficult suspects or others displaying threatening behavior.
